tecnolato

The tecnolato coating system is specially designed for the protection of overhead, buried and submerged pipelines and structures. This system consists of a layer of **tecnolato-primer**, a layer of **tecnolato-tape** and a finishing layer for mechanical protection with **tecnolato-shield** (polyethylene tape with butyl adhesive).

CASE STUDY: PENSTOCK

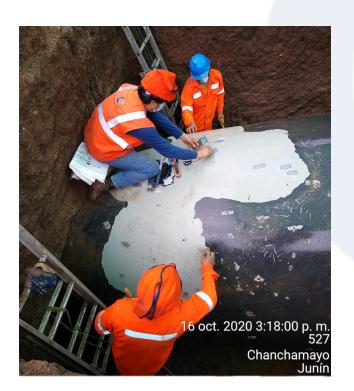
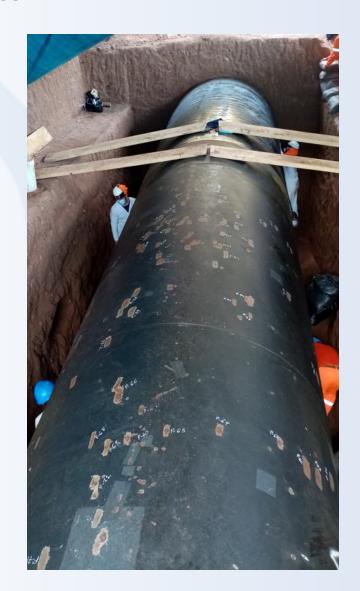
Pipe characteristics

Active: Hydroelectric impulse pipeline

• Diameter: 2 meters

Coating: Two-coat epoxy

Buried service

Failures encountered: Low adhesion and blistering

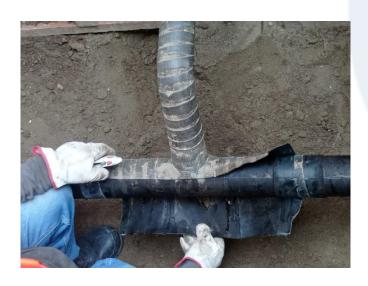
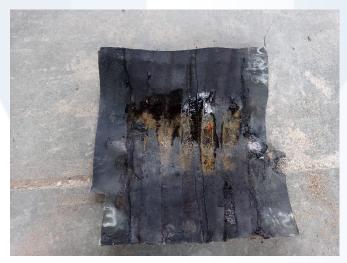
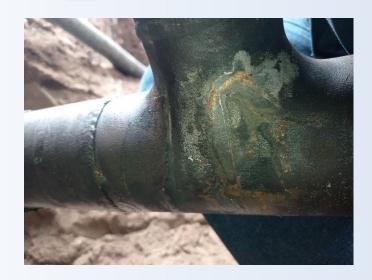
CASE STUDY: TEE PLUS CURVE

Active: Tee plus curve

• Diameter: 2 ½"

Coating: Polyguard Tape

Buried Service

Failures Encountered: Low adhesion, water between coating and pipe

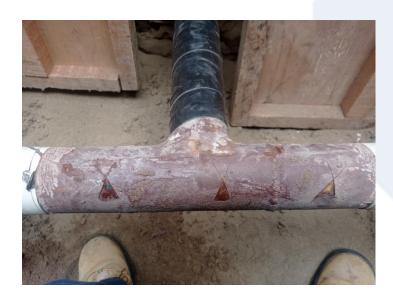
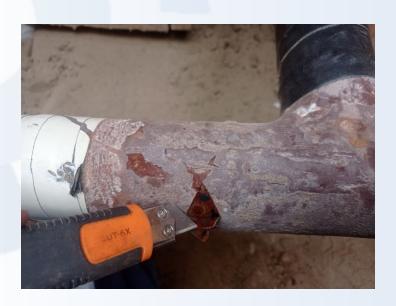
CASE STUDY: TEE

- Tee
- Diameter: 2 ½".
- Coating: Epoxy plus polyethylene tapes
- Buried Service
- Failure Found: Adhesion rating 0, easily peeled more than 6.3 mm per ASTM D677. Peeling, delamination.

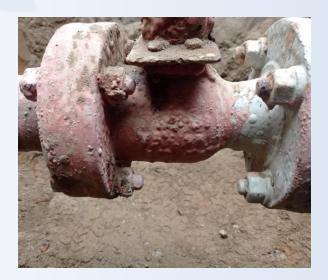
CASE STUDY: SERVICE VALVE

- Service valve with extenders
- 2 ½" diameter
- Epoxy coating plus polyethylene tapes
- Buried service
- Failure Found: Size No. 2 Medium dense ASTM D714 blistering, undercutting, rust staining, flaking.

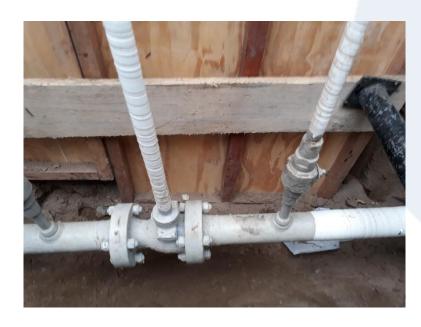
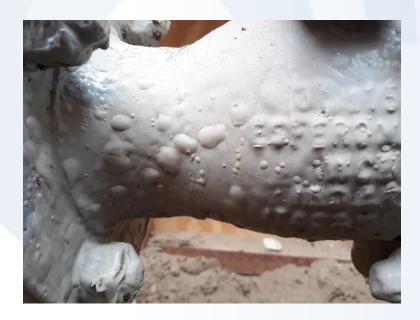
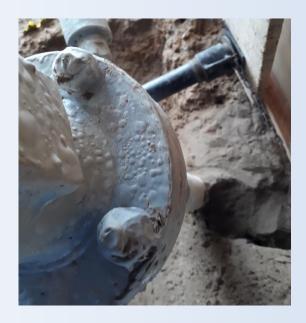
CASE STUDY: SERVICE VALVE

- Service valve with extenders
- 2 ½" diameter
- Epoxy coating plus polyethylene tapes
- Buried service
- Failure Encountered: Size No. 2 Medium dense, ASTM D714
