## Soluciones para tuberías con corrosión

TECNOLOGIA TOTAL le ofrece la mejor solución para sus problemas de corrosión. Los sistemas AquaWrap® & GatorWrap® son lo de alta resistencia utilizados para la rehabilitación y reparación de líneas de transporte y distribución afectadas por corrosión o erosión.

# **PRCI LONG-TERM STUDY OF COMPOSITE REPAIR SYSTEMS**

## PRCI Co-sponsored Long-term Composite Repair Study Year 0 Burst Test Progress Report (December 2008)

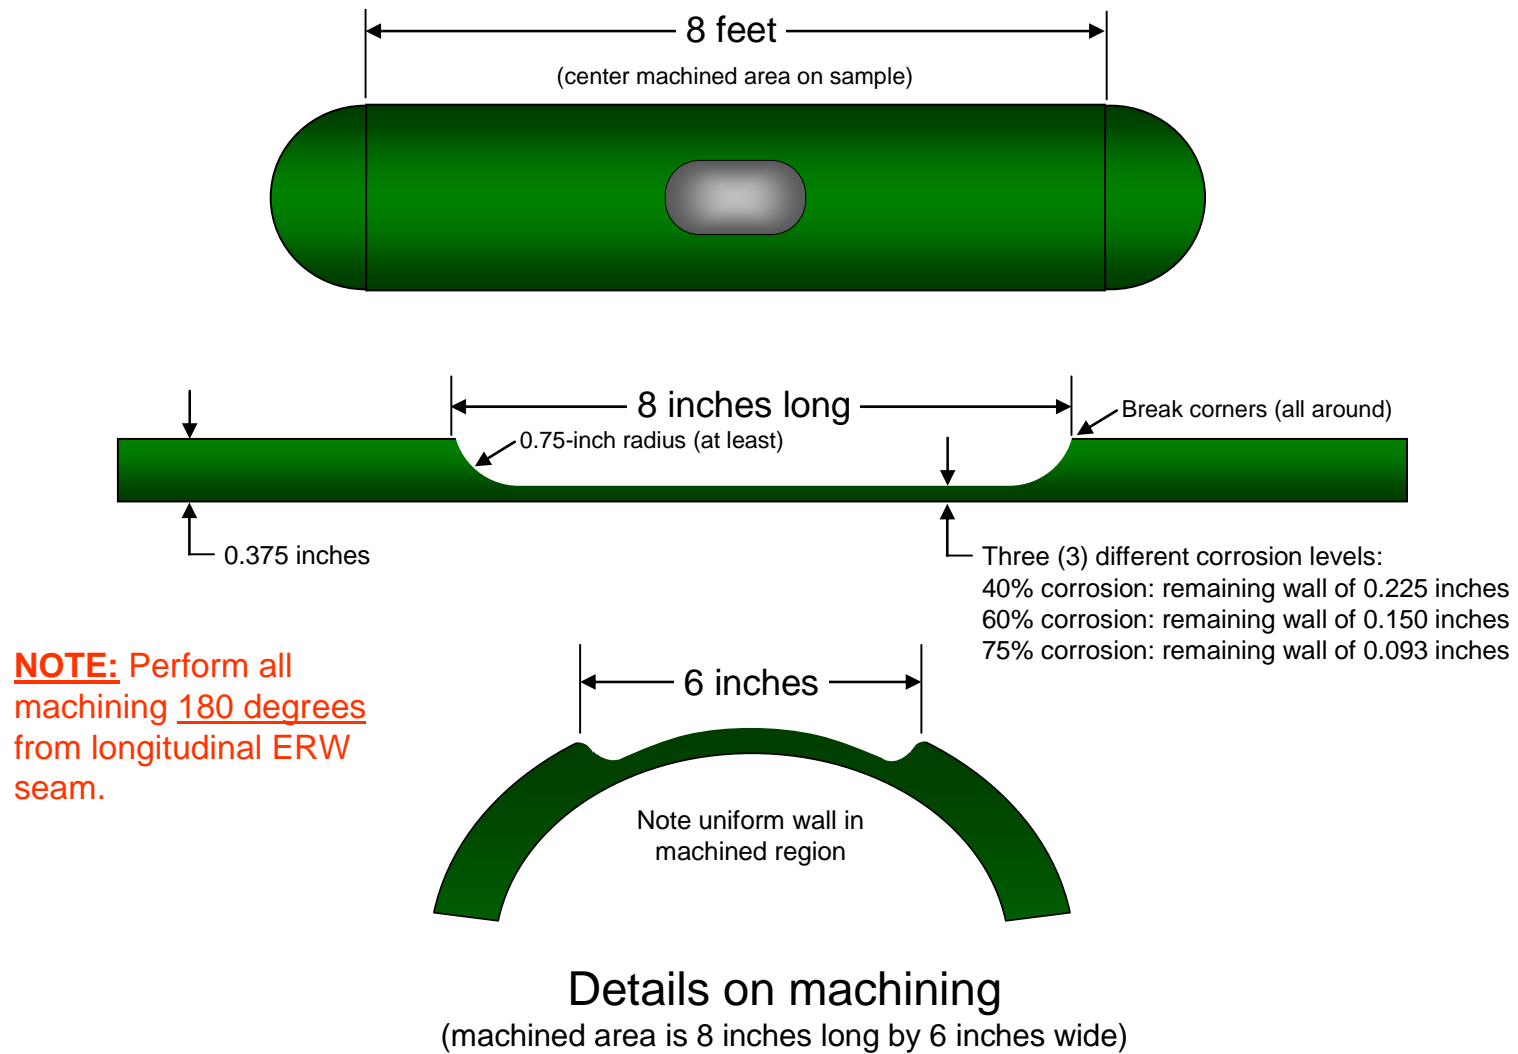
**Figure 1 – Details on machining corrosion in 12.75-inch x 0.375-inch, Grade X42 pipe**  
(target corrosion depth as a percentage of the pipe’s nominal wall thickness as shown)

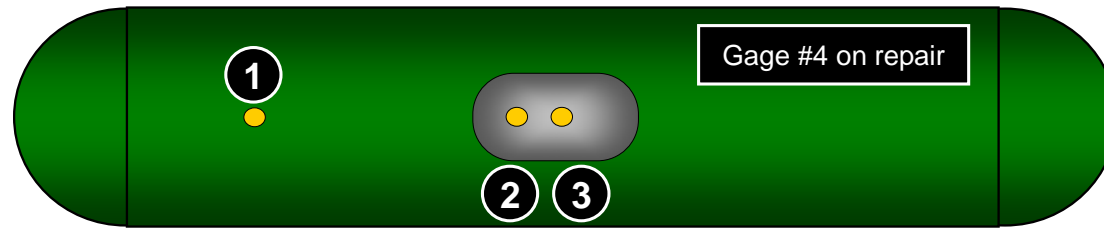
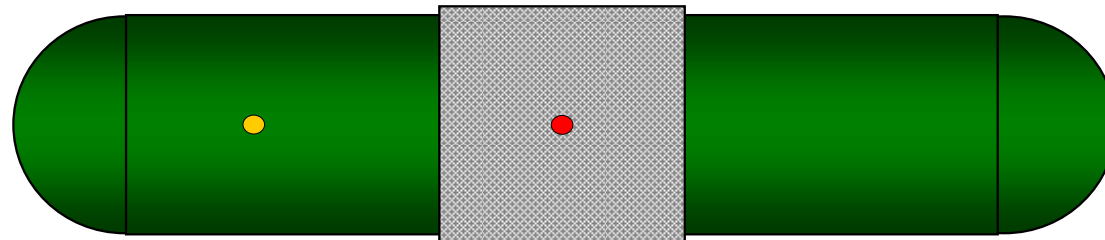
Machined corrosion region (60% of pipe wall thickness)

Strain gage location (1 outside on composite repair)

**Figure 2 – Test sample layout including strain gage locations**

NOTE: The plan for strain gauging is that all samples will have at least one bi-axial gage installed beneath the composite repair (Gage #3 in above figure); however, only one-third of all samples will have all four strain gages installed as shown above. In having strain gages installed beneath all repairs, this will permit SES to monitor the critical information regarding load transfer from the pipe to the composite as a function of time. Every effort will be made to ensure survival of the strain gages, although there are no guarantees that these gages will remain on the samples during all stages of testing.

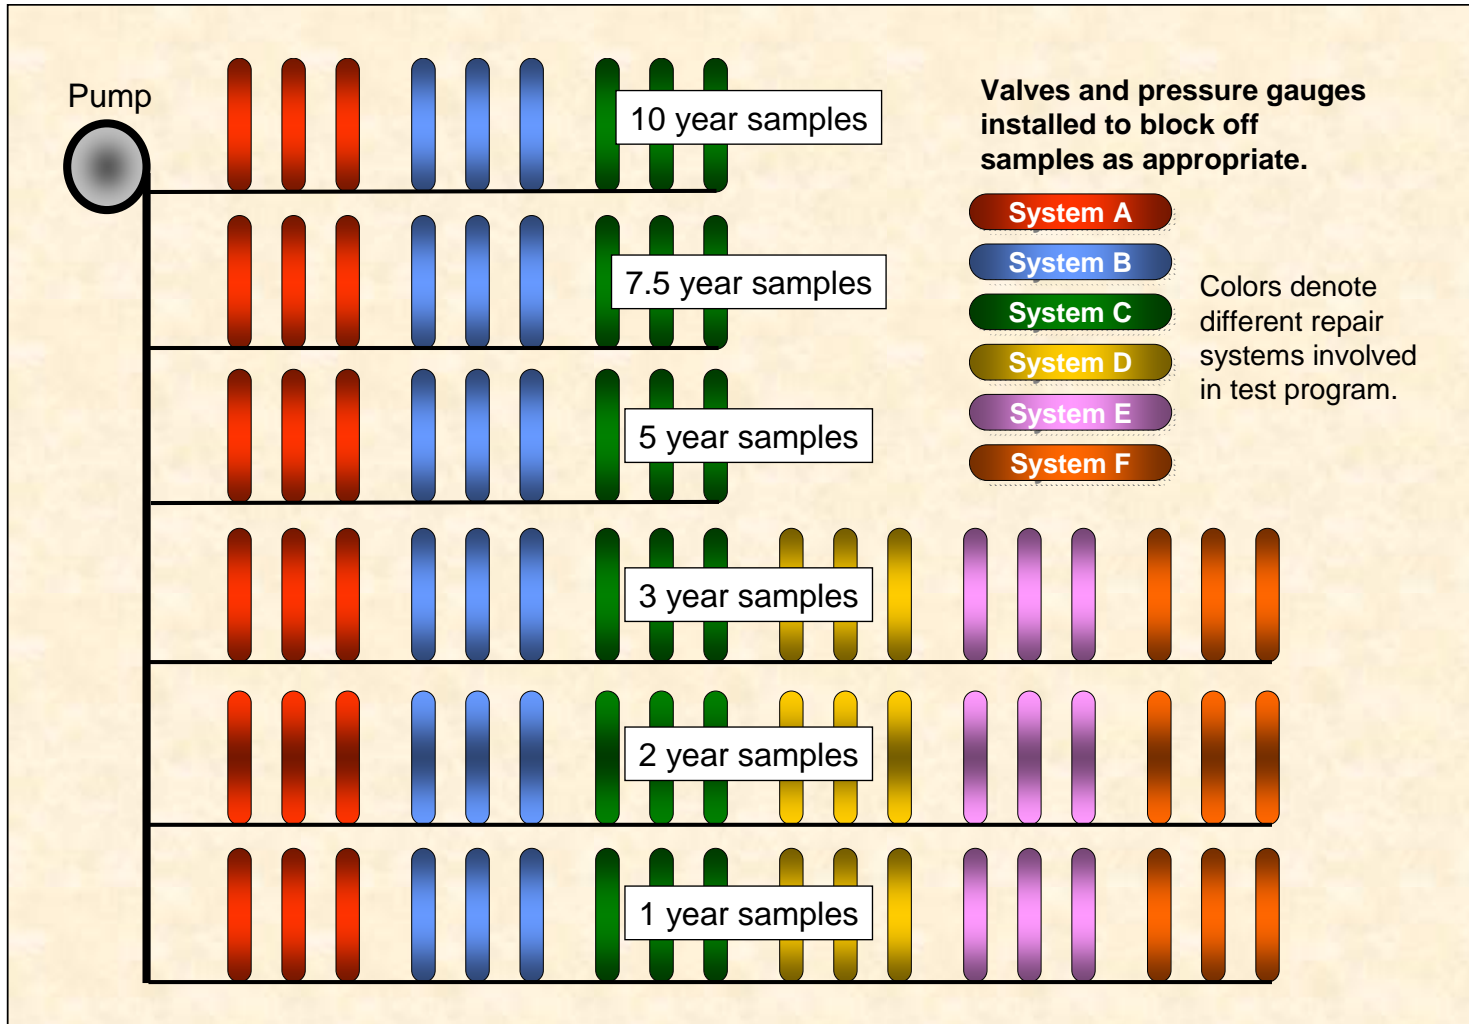
**Figure 3 – Layout for buried pipe samples**  
 (the layout shown above only includes six total repair systems: three for the 3-year study and three for the 10-year study)

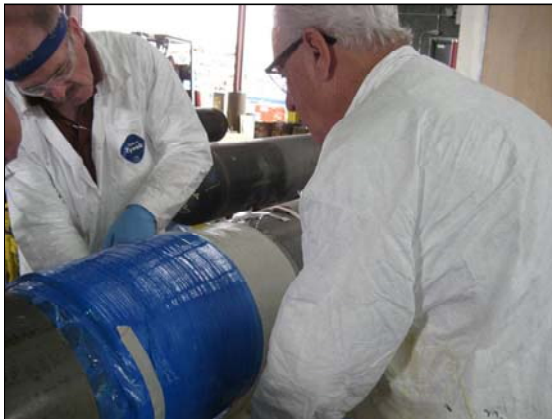
All burst test failures occurred outside of the repairs. The recorded strain gage readings were relatively low and would be considered acceptable for design conditions associated with a typical transmission pipeline system

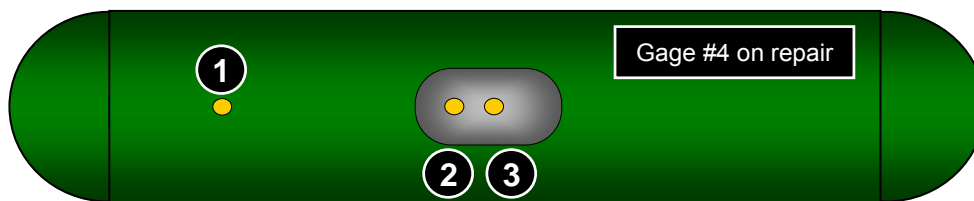
Location of strain gages installed on the test sample

- The pressure levels for the pipe are MAOP = 1,778 psi and SMYS = 2,470 psi.
- Refer to **Figure 1** on the attached page for the strain gage locations. Gage #4 on the outside of the repair is lined up with Gage #3 on the machined corrosion region.
- The strain gage results are in units of microstrain ( $\mu\epsilon = 10^{-6}$  in/in). Elastic stress is calculated by multiplying strain by the material's elastic modulus (i.e. 30 Msi for steel). For example, if the strain in the steel is 1000  $\mu\epsilon$ , the stress is calculated to be 1000  $\mu\epsilon \times 30$  Msi = 30,000 psi. For the composite material, the elastic modulus will be less than steel.
- The average measured composite thickness values for the 40, 60, and 75 percent samples were 0.690, 0.750, and 0.900 inches, respectively.

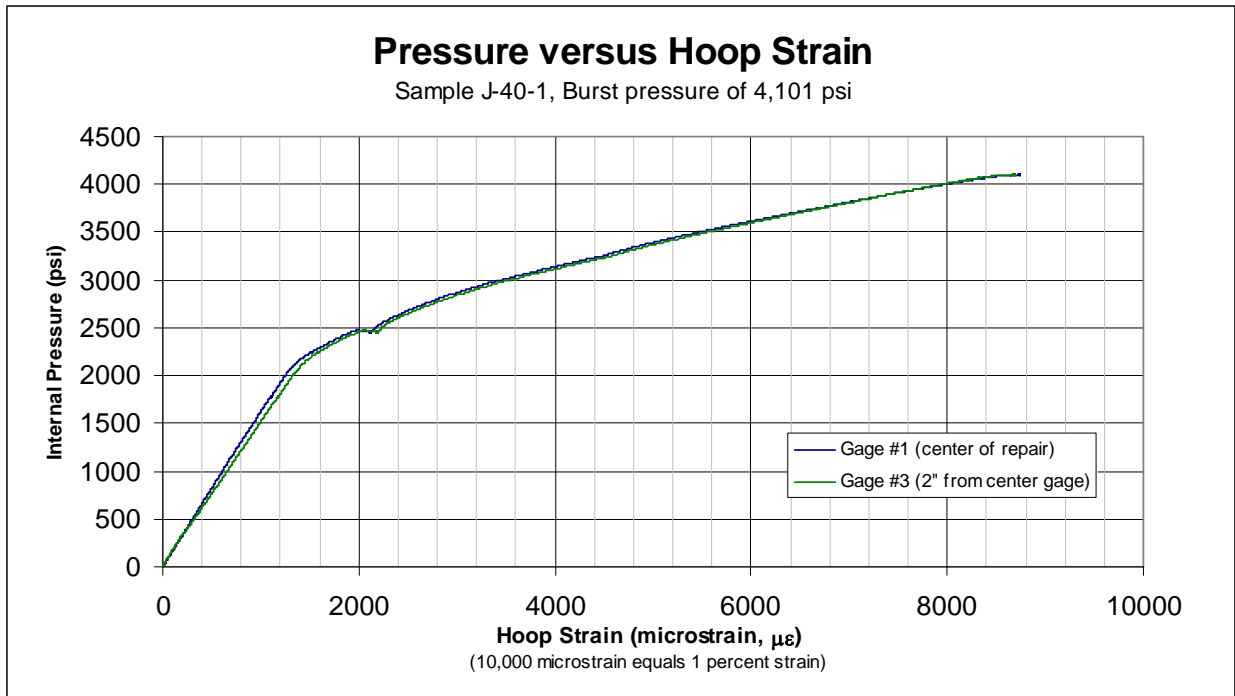
**Figure 1 – Pressure vs. Hoop Strain, 40% Corrosion Sample**

- Figure 1 – Pressure vs. Hoop Strain, 40% Corrosion Sample
- Figure 2 – Pressure vs. Hoop Strain, 60% Corrosion Sample
- Figure 3 – Pressure vs. Elapsed Time, 75% Corrosion Sample
- Figure 4 – Photograph of Failure Location, 40% Corrosion Sample
- Figure 5 – Photograph of Failure Location, 60% Corrosion Sample
- Figure 6 – Photograph of Failure Location, 75% Corrosion Sample
- Figure 7 – Pressure Transducer Calibration Certificate

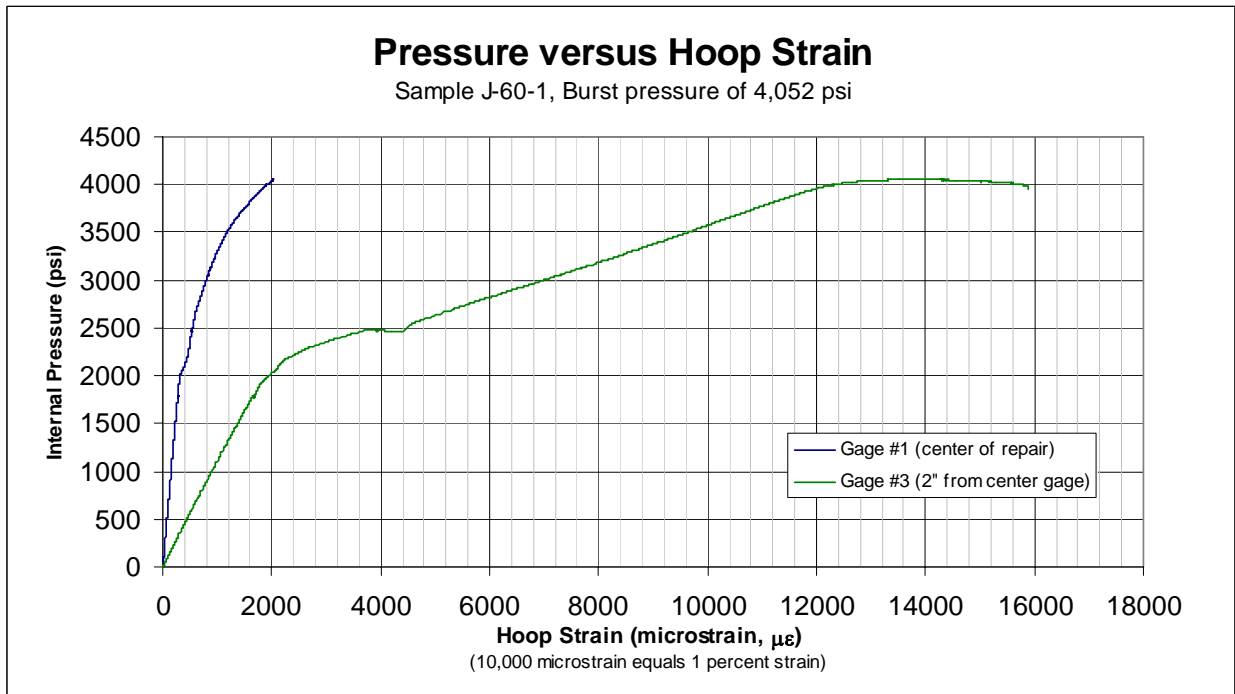
**Figure 2 – Pressure vs. Hoop Strain, 60% Corrosion Sample**

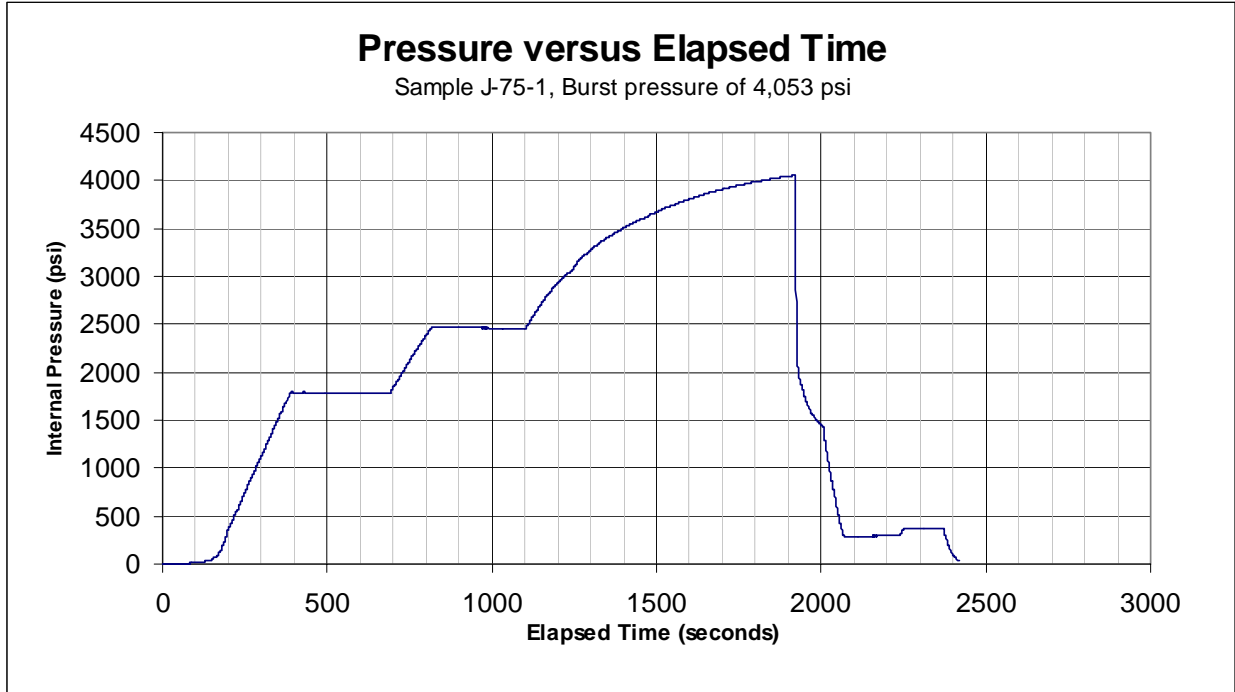
**Figure 3 – Pressure vs. Elapsed Time, 75% Corrosion Sample**

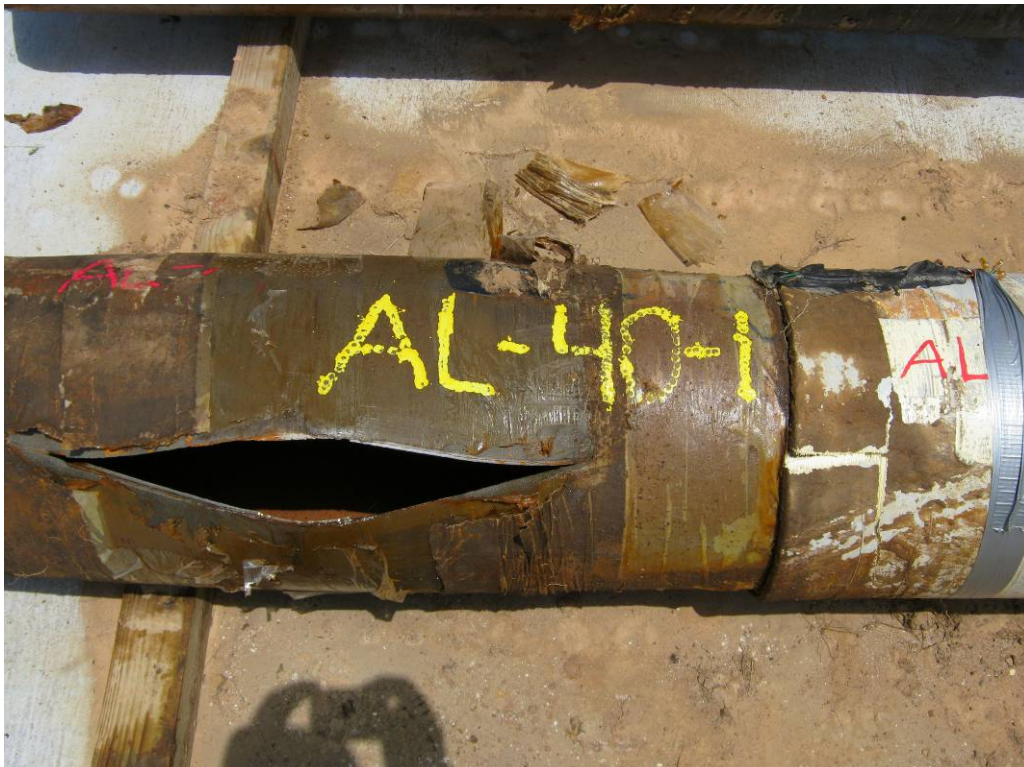
**Figure 4 – Photograph of Failure Location, 40% Corrosion Sample**

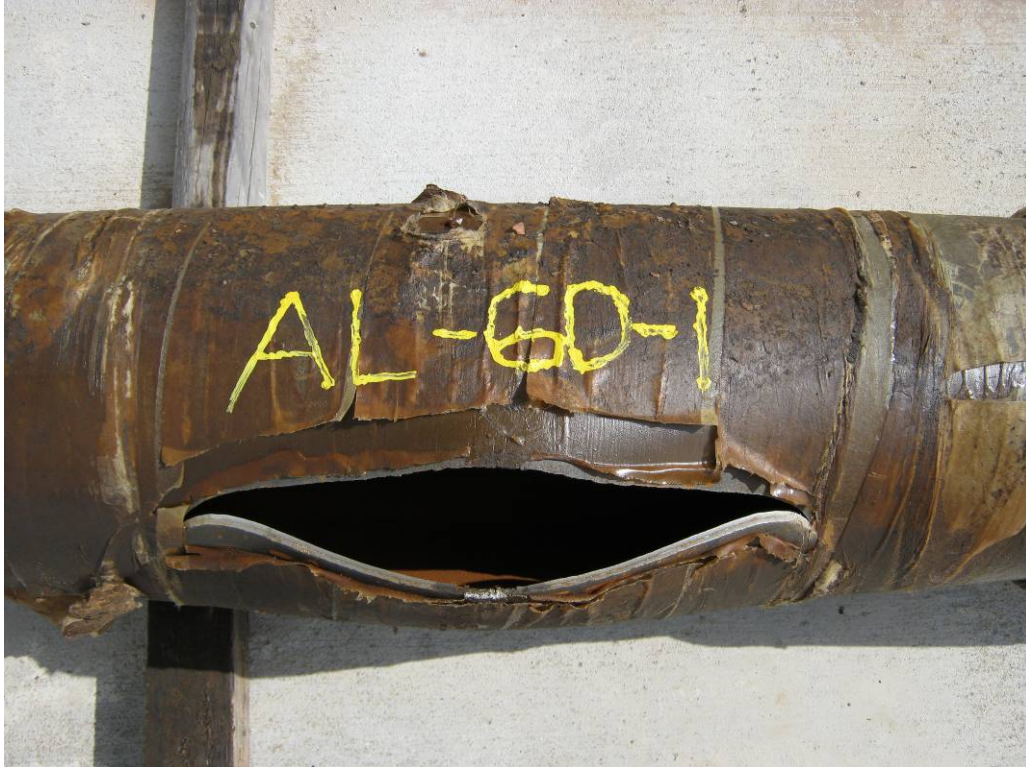
**Figure 5 – Photograph of Failure Location, 60% Corrosion Sample**

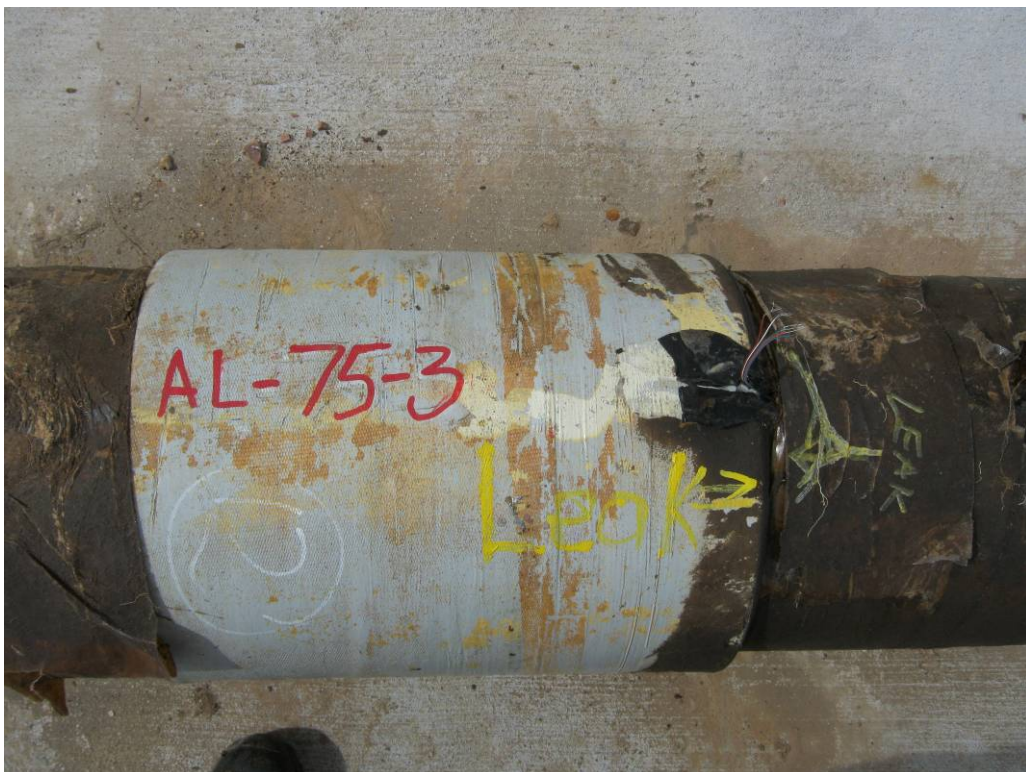
**Figure 6 – Photograph of Failure Location, 75% Corrosion Sample**

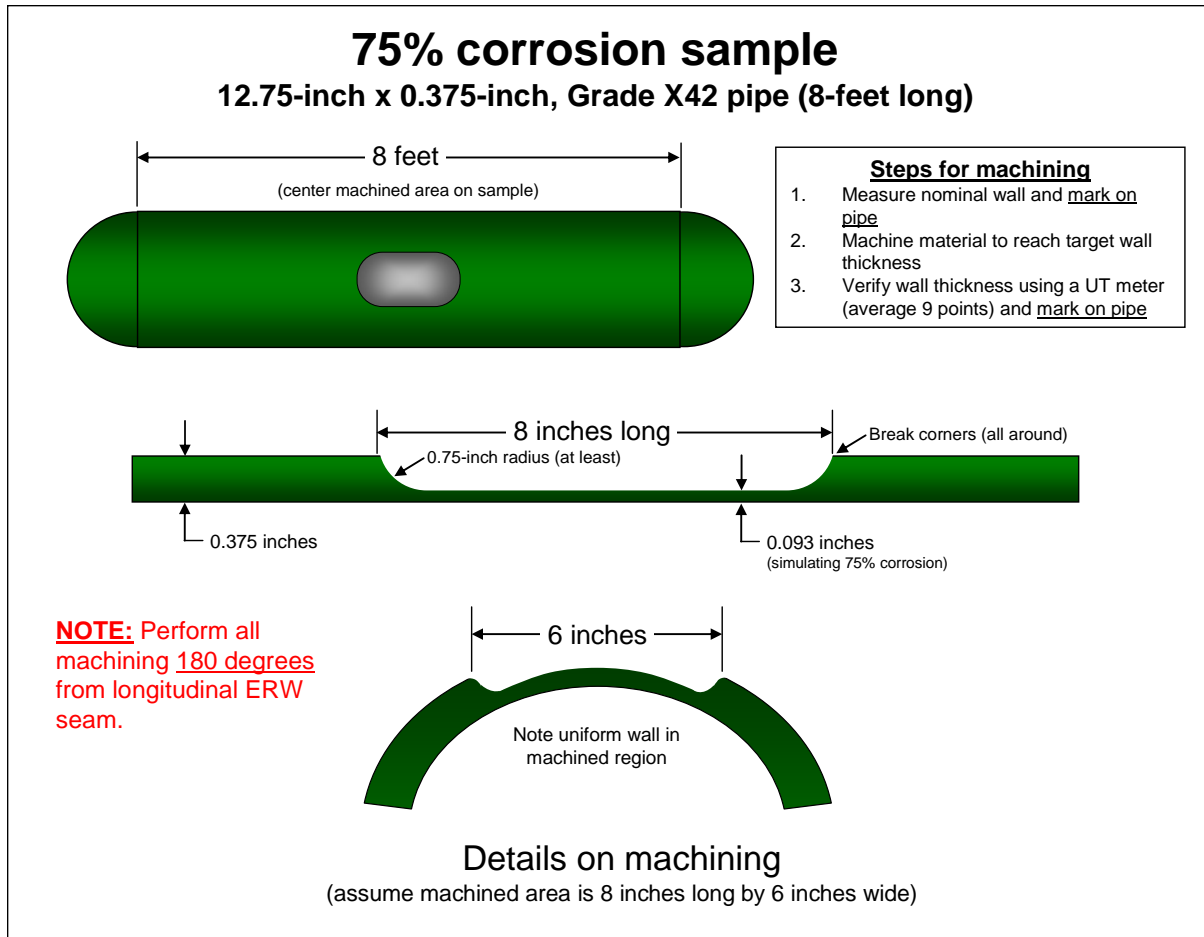
**Figure A - Sketch of simulated corrosion**

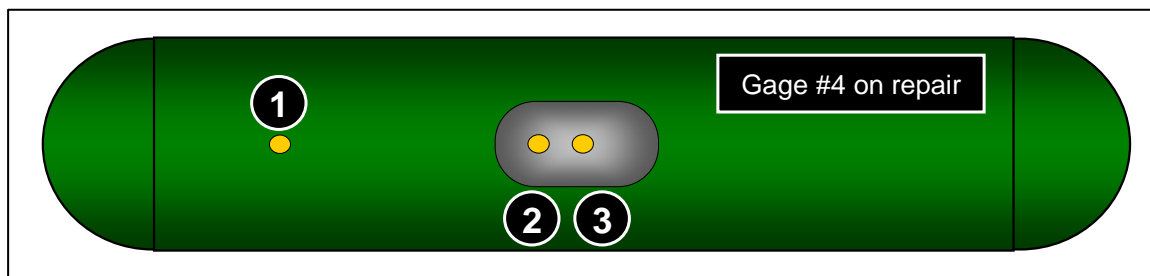
**Figure B- Diagram of strain gage locations**

- During the testing period, strain gages will be used to monitor strain in the corroded steel beneath the composite repairs. Figure B and Figure C provide a schematic of the strain gage locations and a photograph of the machined region with strain gages, respectively.

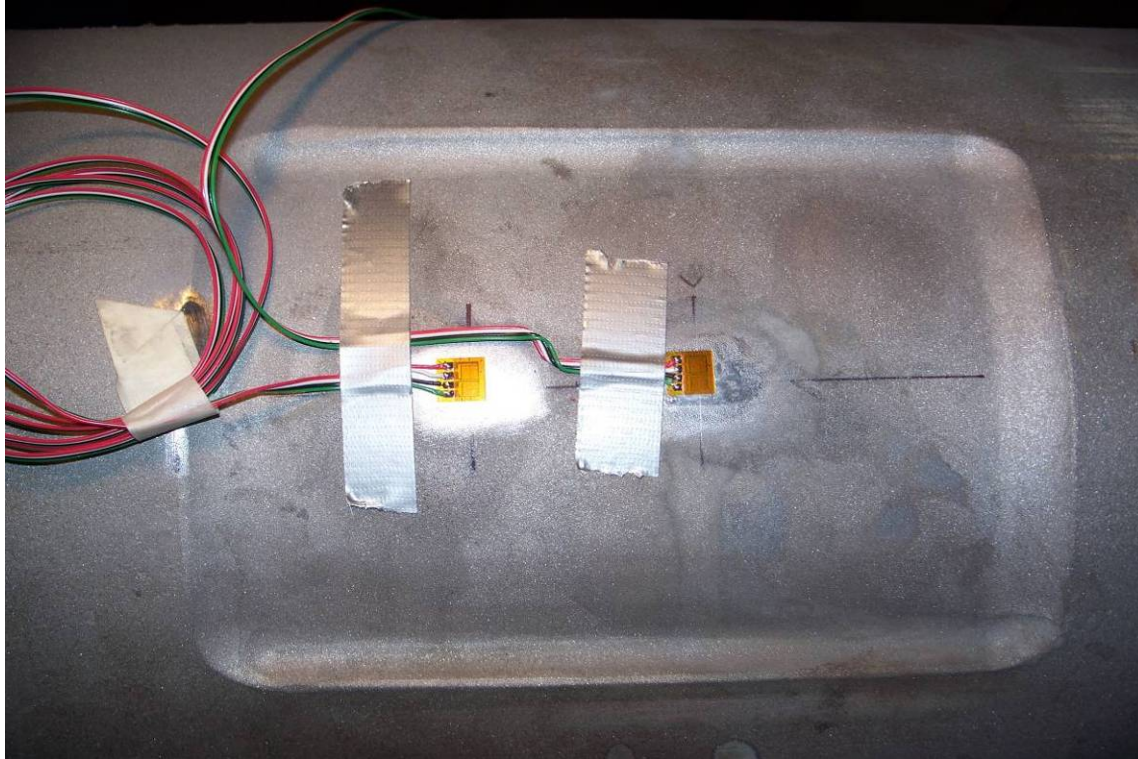
**Figure C - Strain gages in simulated corrosion**

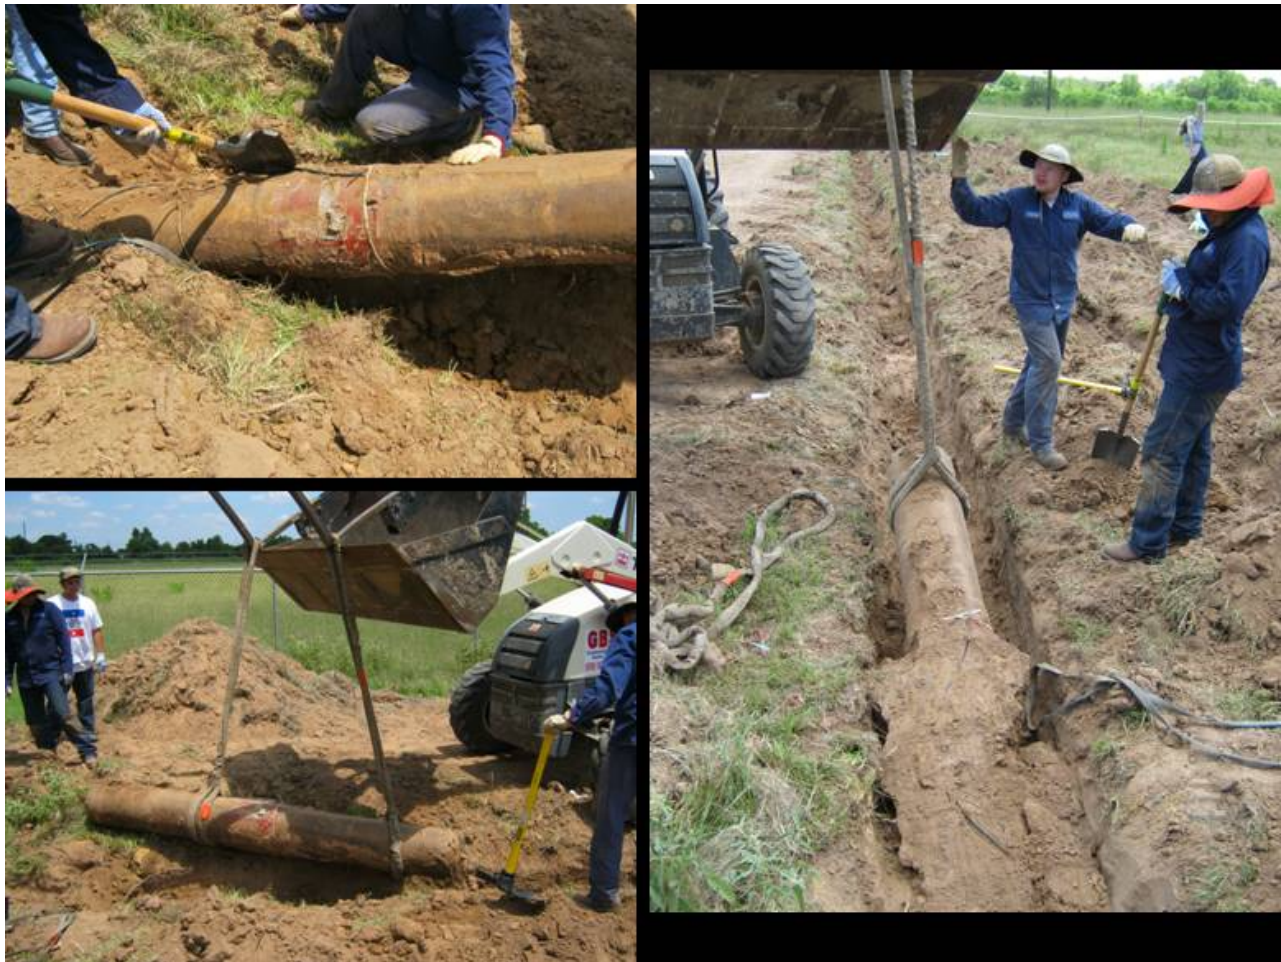
**Figure D - Photographs from Year 1 sample removal**

The 36 samples from the Year 1 group were unearthed prior to burst testing. Figure D provides photographs taken during the pipe removal activities.

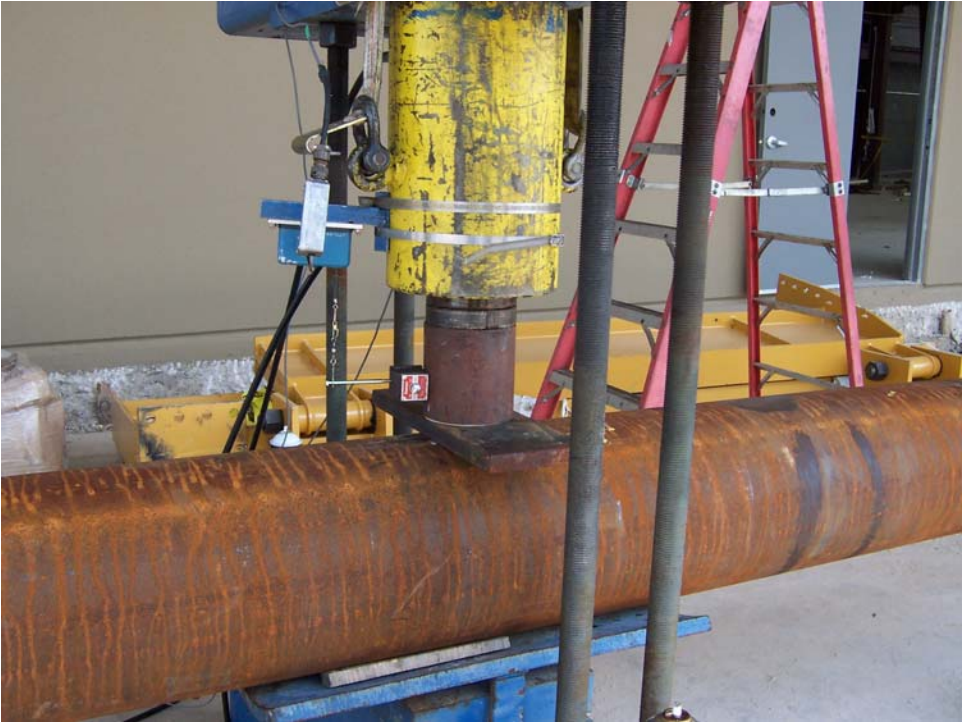
**Figure 1 - Dent installation rig to install dents**

- [3] Install dents in the pipe using a 6-inch wide plate. The initial indentation depth will be 15 percent of the pipes outer diameter and the indenter plate. Four dents will be installed in each 20-ft long pipe samples. Each dent will be offset 2 inches longitudinally from the respective gouge, resulting in a total defect length of 8 inches. **Figure 1** shows the dent installation rig.

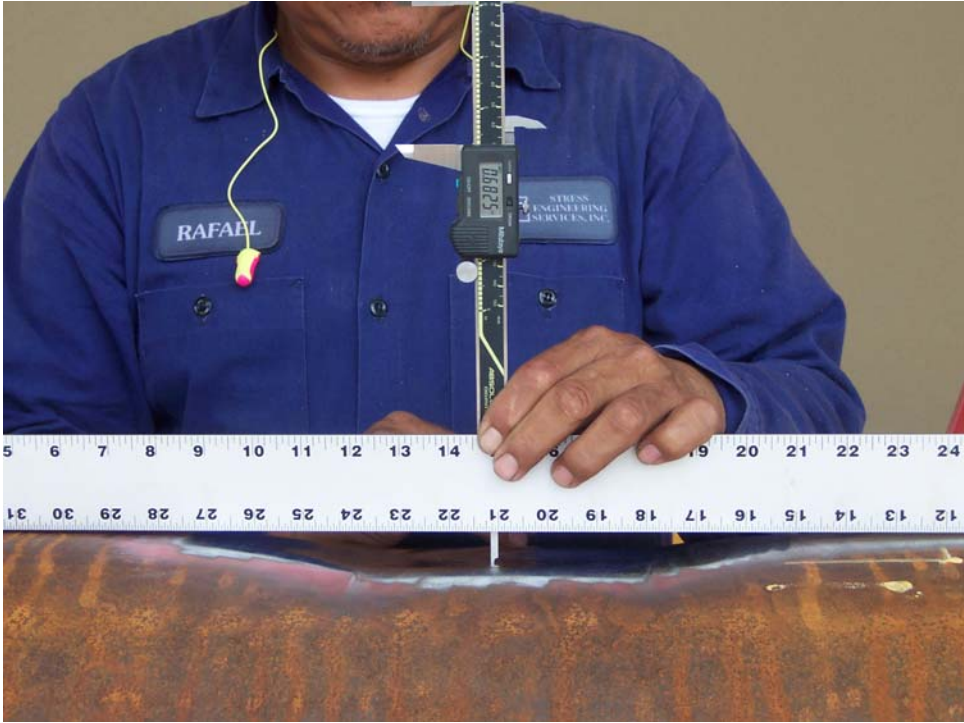
**Figure 2 - Measuring dent depth and profile**

- [4] Allow each dent to reround elastically with removal of the indenter and measure the longitudinal profile (side view of dent and process shown in **Figure 2**).

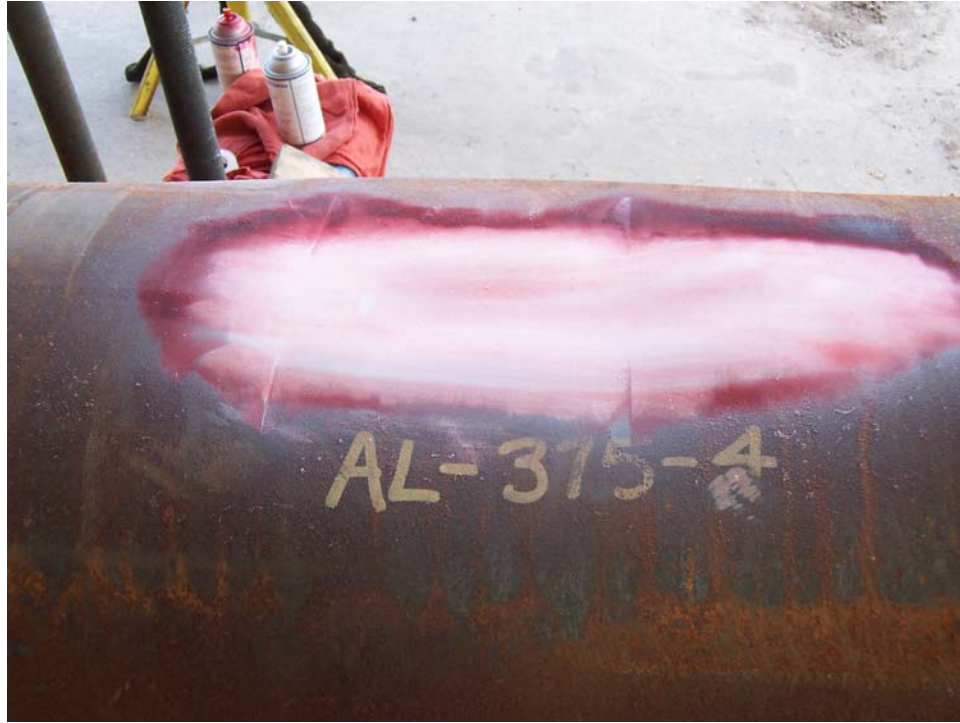
**Figure 3 - Dye penetrant used to ensure gouge removal by grinding**

- [1] Remove the gouge by grinding with a hand-held grinder. Dye penetrant was used to ensure that the crack was completely removed. Measure the remaining wall thickness. **Figure 3** shows the application of dye penetrant to the damaged region and **Figure 4** shows one of the samples polished in its final state before installation of the repair material.

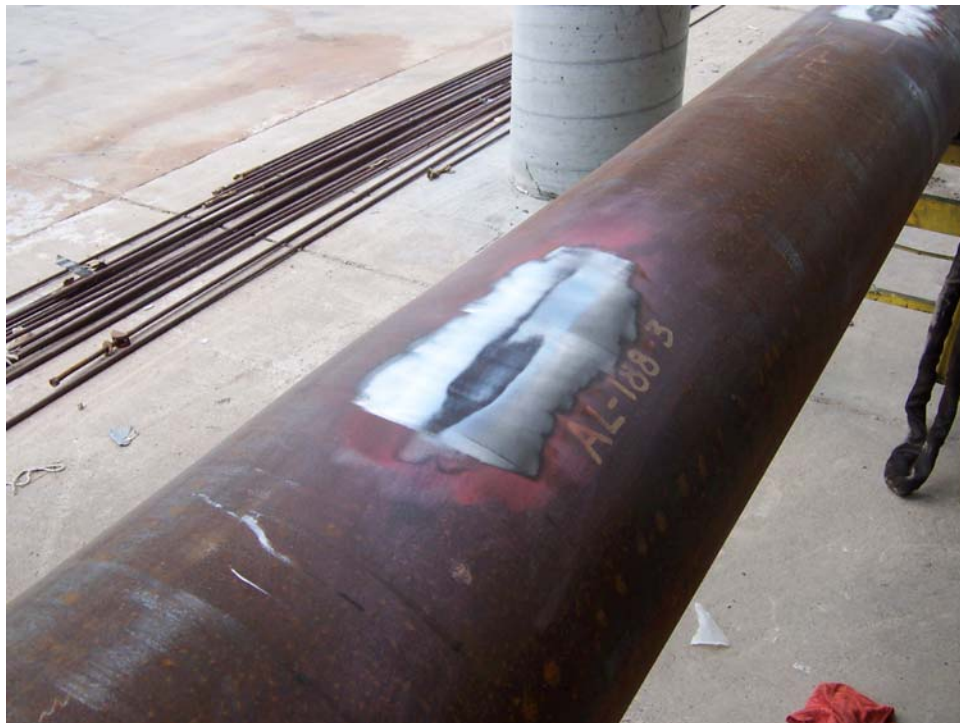
**Figure 4 - Gouge removed by grinding**

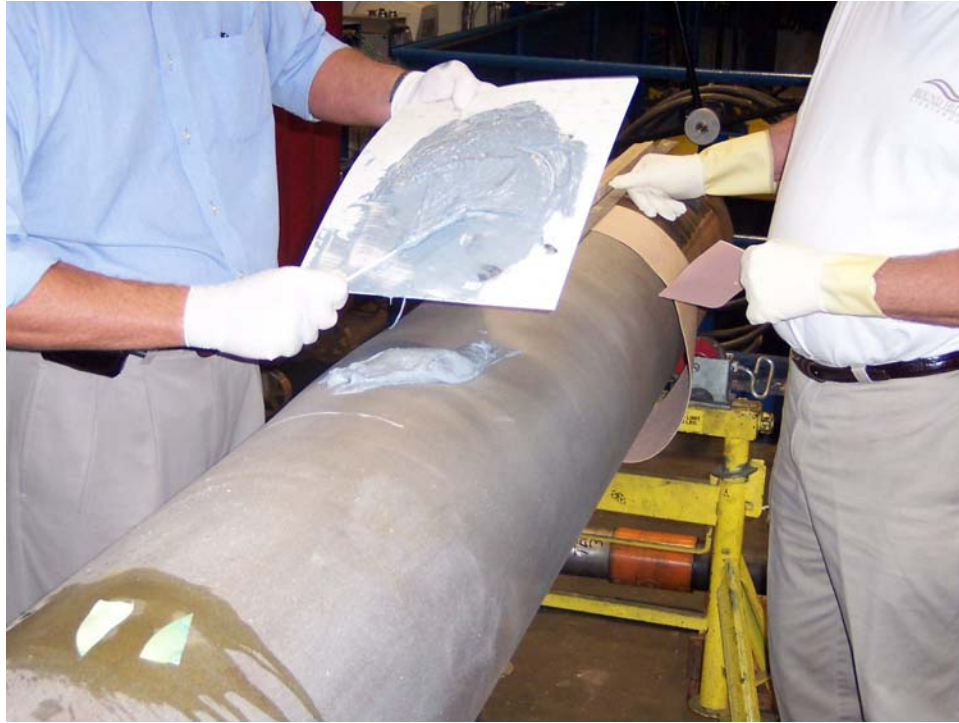
**Figure 5 - Epoxy material used to fill the dented region**

**Figures 5 through 8** are photographs taken during the installation of Aquawrap™ on the damaged sections of the test pipes.

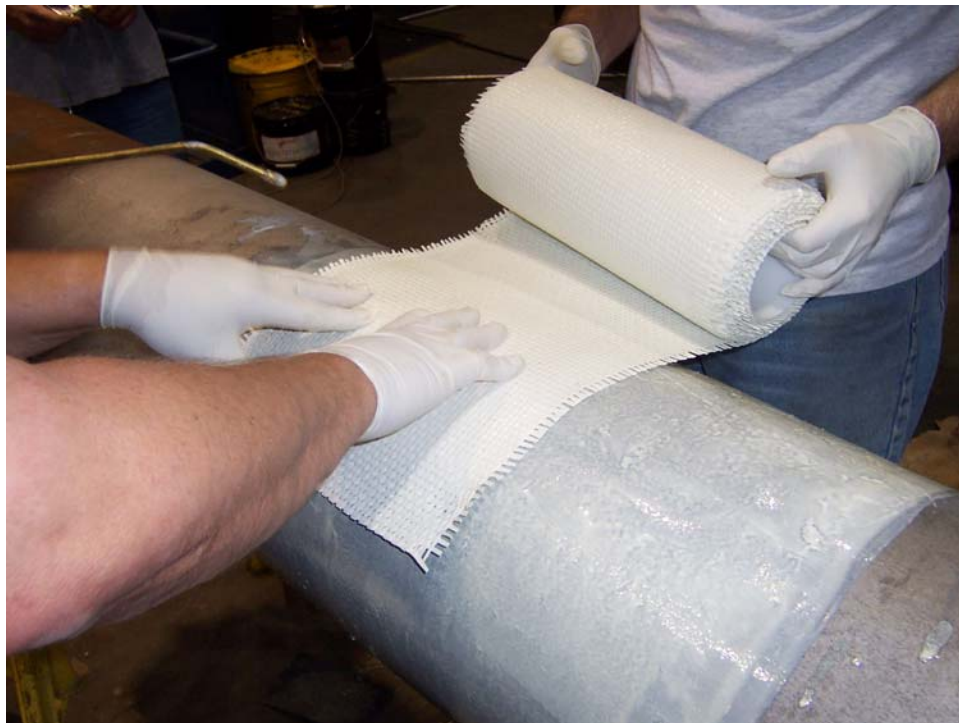
**Figure 6 - First layer of Aquawrap™ installed on pipe**

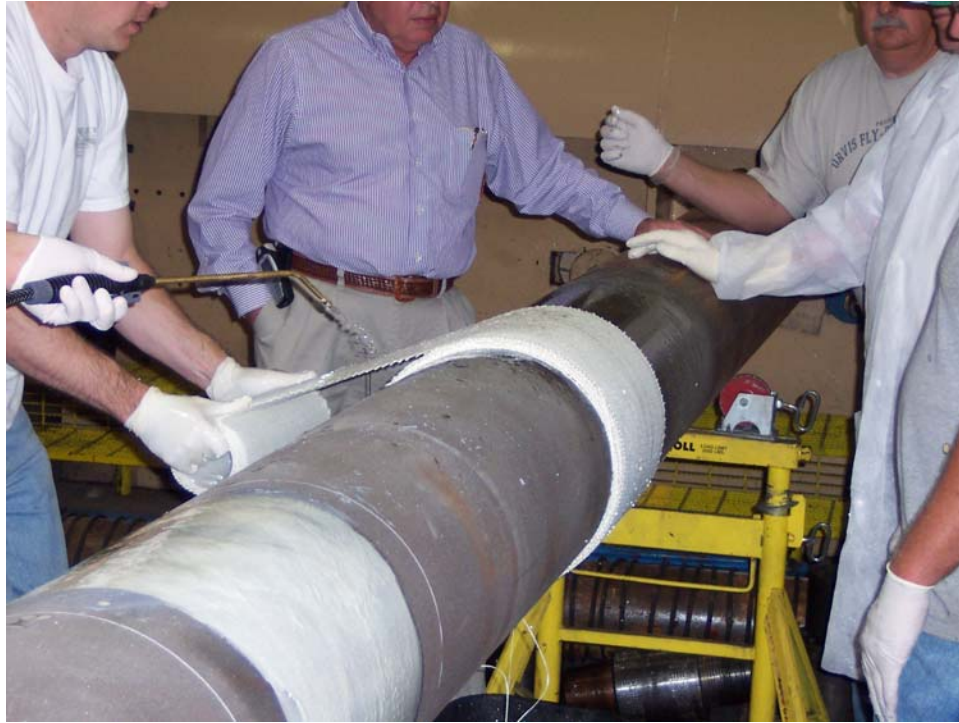
**Figure 7 - Continued wrapping of Aquawrap™ in repairing damage**

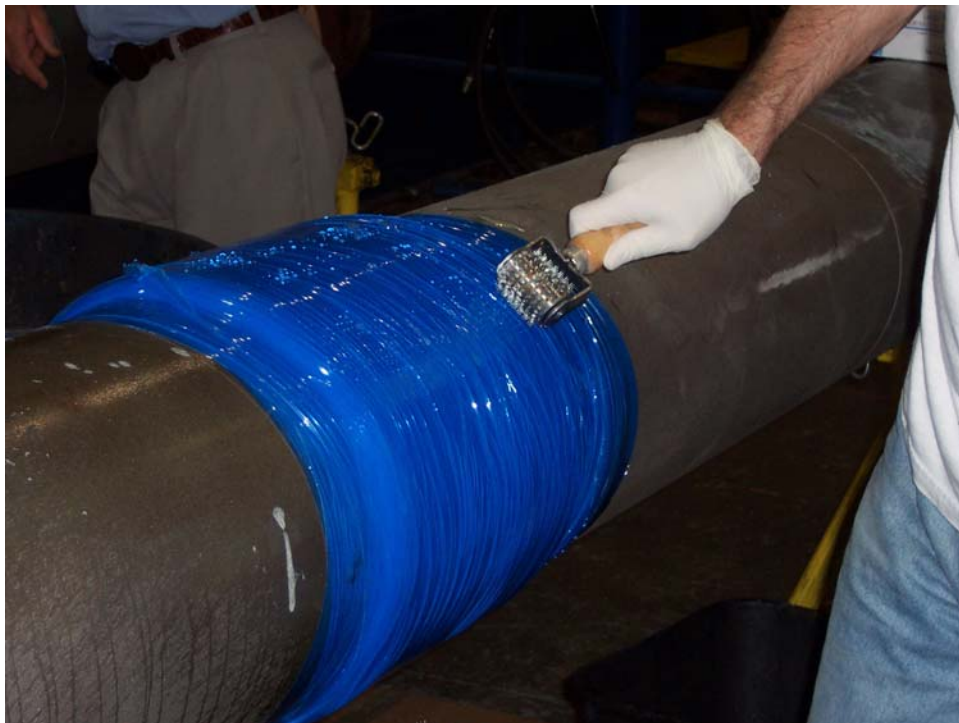
**Figure 8 - Perforating plastic wrap to permit off-gassing during cure**

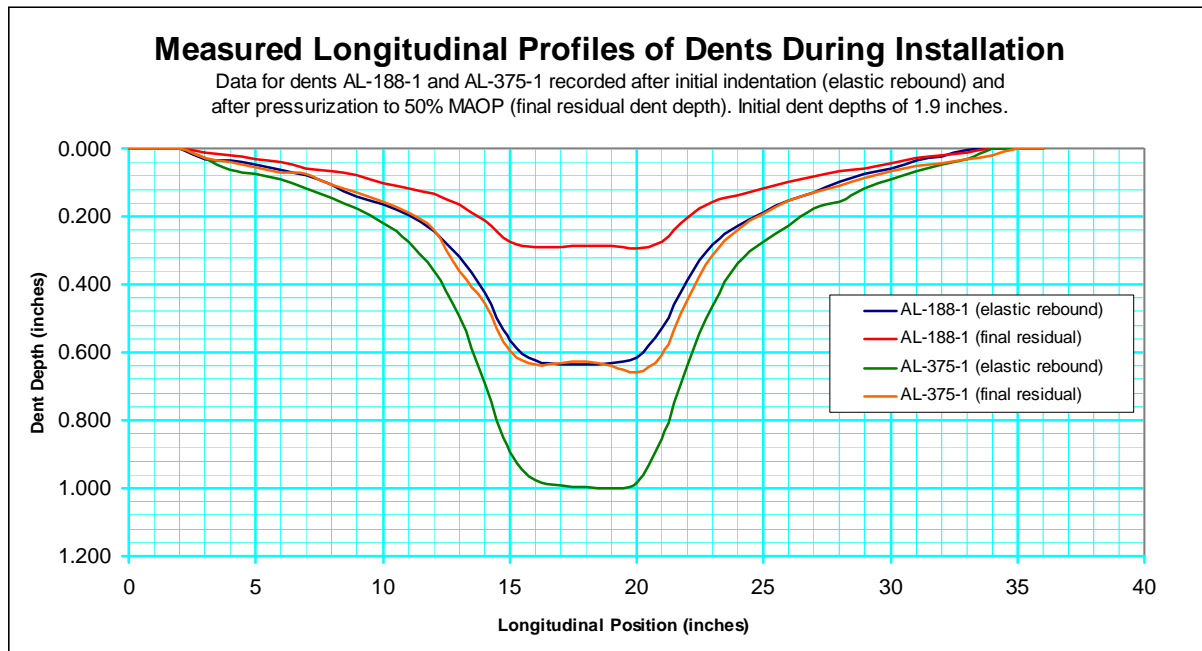
**Figure 9 - Longitudinal profile measurements of exemplar dents**

**Figure 9** shows the longitudinal profile measurements for test samples AL-188-1 and AL-375-1. The measurements correspond to readings taken after initial indentation that capture the elastic rebound and measurements taken after pressurization to 50 percent MAOP. As with the data presented in **Table 1**, it is clear that a significant portion of the dent is removed by the application of internal pressure.

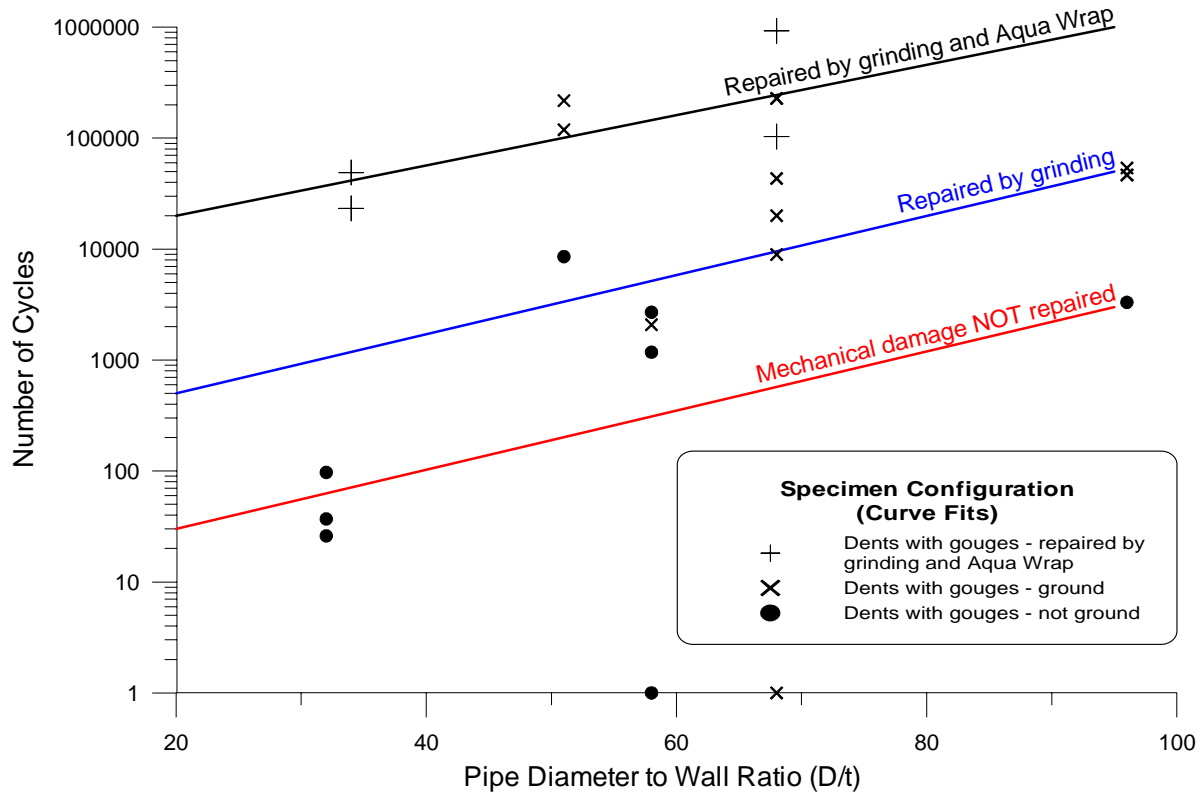
Data plotted are based on a cyclic pressure range of 50% MAOP  
 All defects involved a dent of 15 percent (d/D) and a gouge depth of 15 percent (d/t)

**Figure 10 - Fatigue test results for mechanically-damaged samples**

In addition to the tabulated data, fatigue results are presented in **Figure 10** that plots cycles to failure for the Aquawrap™ samples as well as data from previous research programs associated with mechanical damage. The predominant observation made in viewing this figure are the benefits derived in repair by grinding and using composite materials as compared to unrepaired mechanical damage. If one considers a pipe having a D/t ratio of 50 with a dent of 15 percent and a gouge of 15 percent, the fatigue life can be estimated from **Figure 10** as follows.

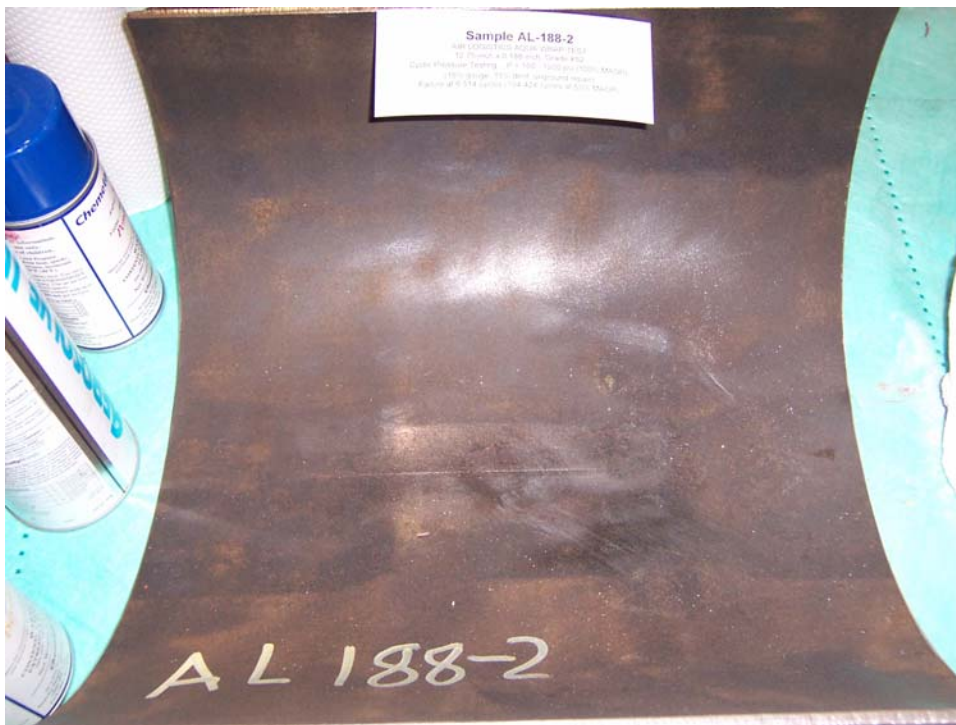
**Figure 12 - Post-failure photo of Sample AL-188-2**

**Figures 11, 12, 13, and 14** show failures for samples AL-188-1, AL-118-2, AL-375-1, and AL-375-2, respectively. The key point to note is the radial deformation that occurs in the unrepaired defects (AL-188-1 and AL-375-1). The extensive deformation associated with the unrepaired defects confirms that the filler material must have a sufficient level of rigidity to prevent the radial deformation due to internal pressure.
