## Soluciones para tuberías con corrosión

TECNOLOGIA TOTAL le ofrece la mejor solución para sus problemas de corrosión. Los sistemas AquaWrap® & GatorWrap® son lo de alta resistencia utilizados para la rehabilitación y reparación de líneas de transporte y distribución afectadas por corrosión o erosión.

# **PRCI LONG-TERM STUDY OF COMPOSITE REPAIR SYSTEMS**

## PRCI Co-sponsored Long-term Composite Repair Study Year 0 Burst Test Progress Report (December 2008)

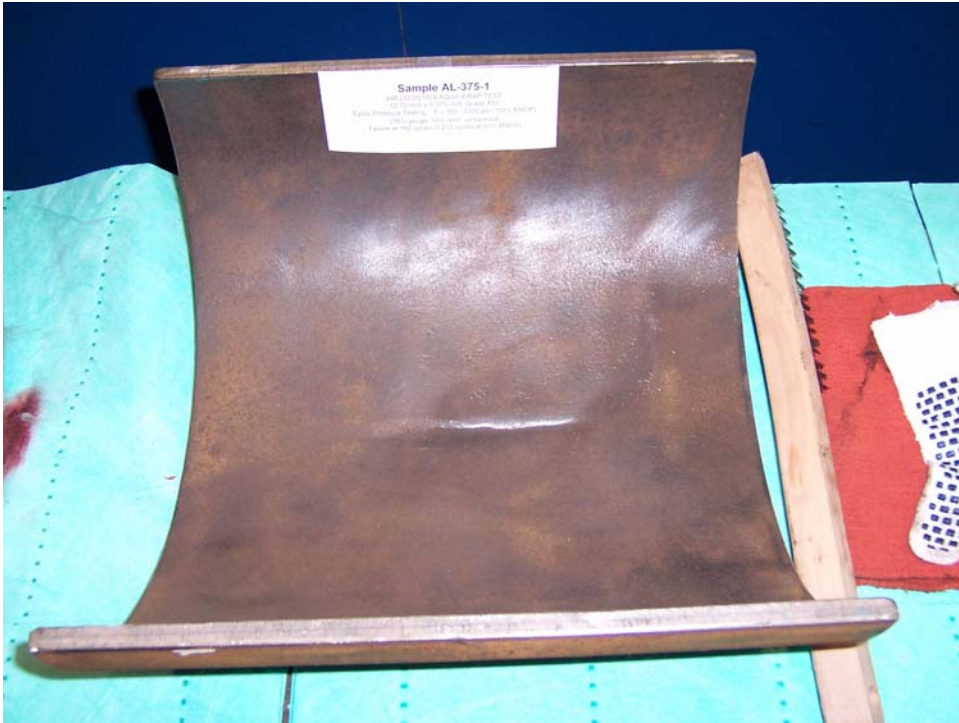
Figure 13 - Post-failure photo of Sample AL-375-1

**Figures 11, 12, 13, and 14** show failures for samples AL-188-1, AL-118-2, AL-375-1, and AL-375-2, respectively. The key point to note is the radial deformation that occurs in the unrepaired defects (AL-188-1 and AL-375-1). The extensive deformation associated with the unrepaired defects confirms that the filler material must have a sufficient level of rigidity to prevent the radial deformation due to internal pressure.

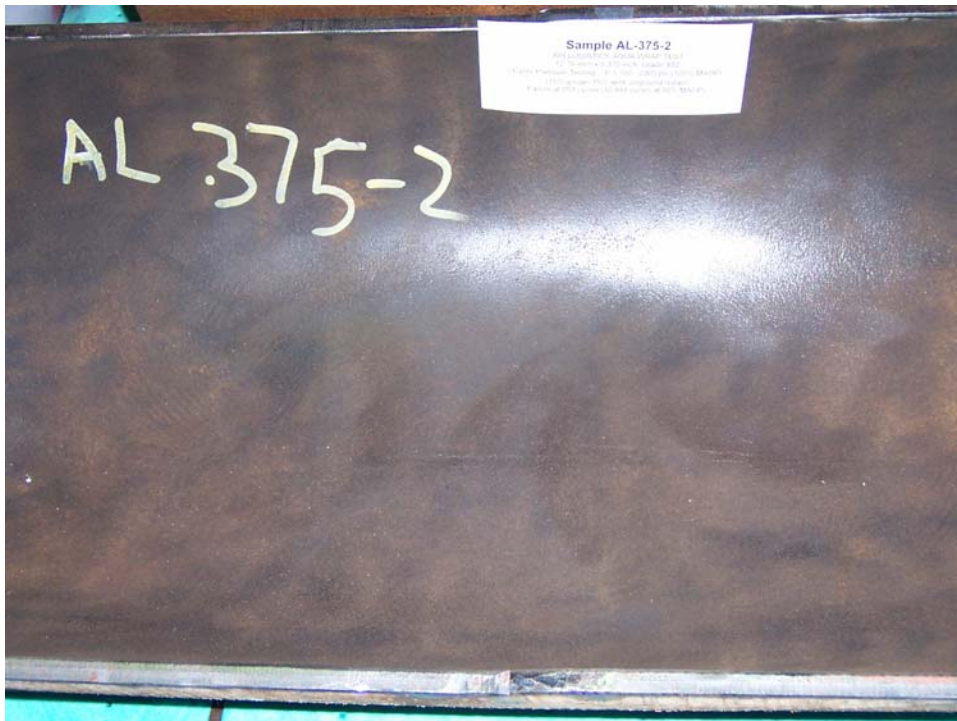
Figure 14 - Post-failure photo of Sample AL-375-2

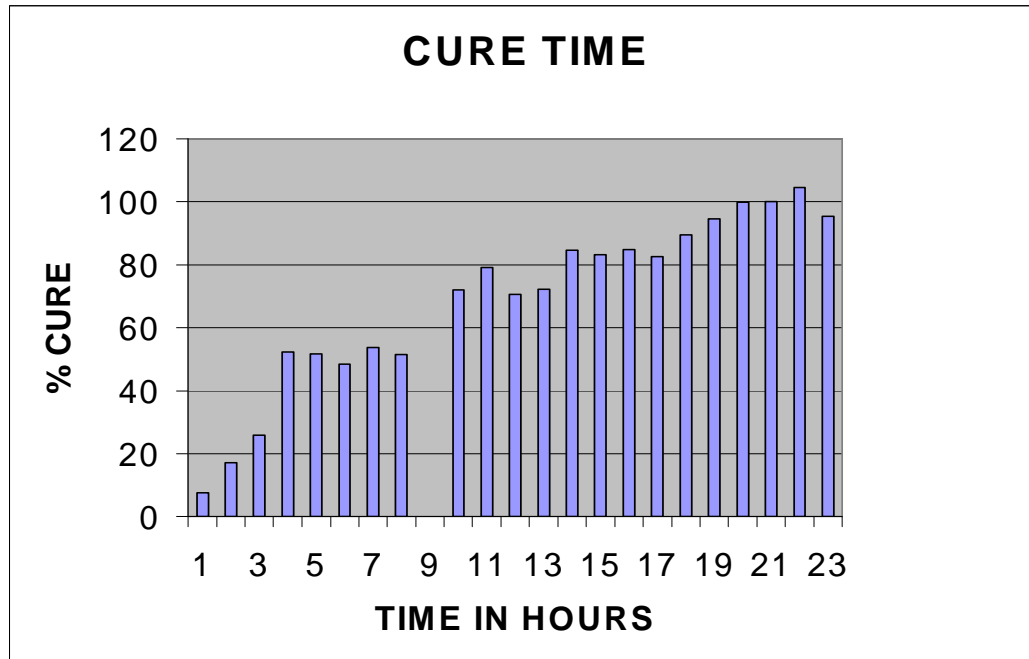
3.14 Cure Time: The results of the cure time were converted into percent of the final interlaminar shear strength. These tests were completed on coupons over 0.25" thick to simulate the cure of a thick lay-up. Due to the coupon thickness, the data needed to be plotted and then analyzed to determine the actual cure times of each sample.

The conclusion is that the material cures to about 60% of its final strength in about 8 hours.

3.13 Tensile Properties at elevated temperatures: See paragraph 3.21 for creep-rupture test details. The slope of the load vs. cycles to failure for the room and elevated temperature (160°F) tests were the same and the offset between the plots is 9%. This indicates that the creep-rupture performance at the material at the elevated temperature is 9% lower than at room temperature.

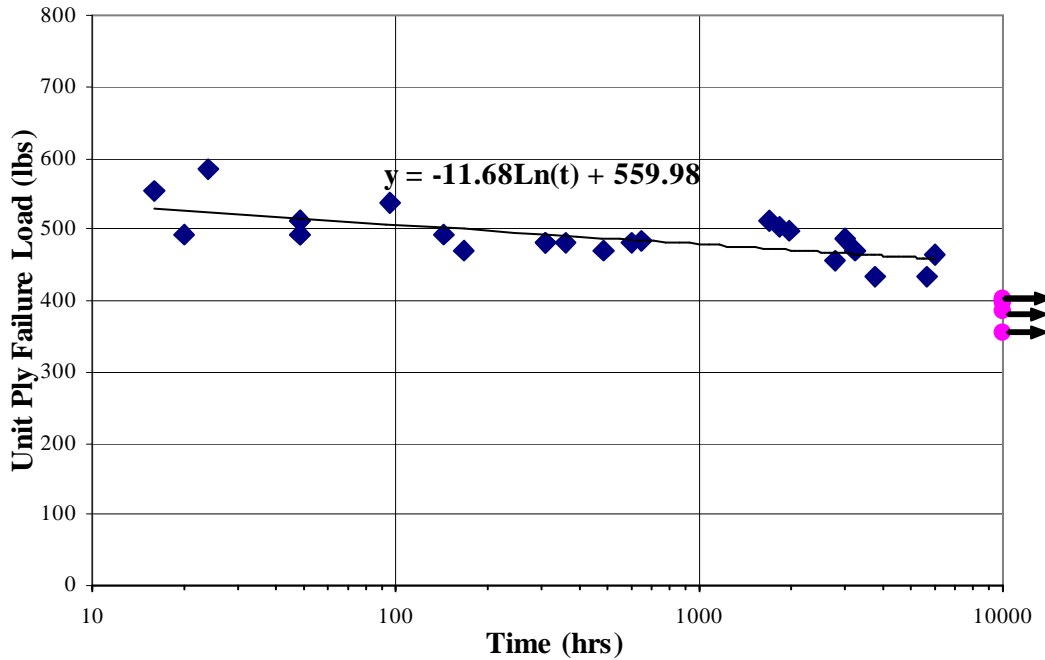
3.21 **Creep Rupture:** Test number 907198. The results of the room temperature 10,000-hour test are shown in the following graphs:

The baseline strength of this 11 oz. tape material is 801 pounds per ply. The 25-year projection of 416 pounds per inch represents a long-term load capability of 52% of its initial tensile strength. The results of the testing at 160° F are shown in the following graph.

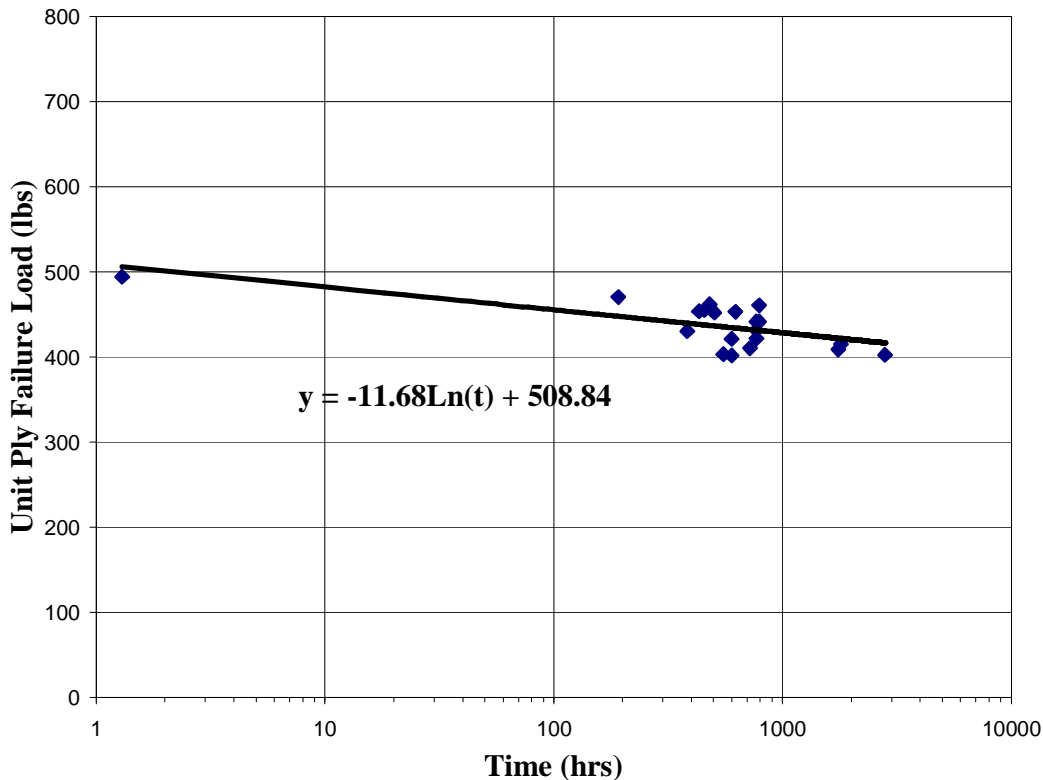
First the slope of the room and elevated temperature plots is identical and the offset between them is 9%. This indicates that the long term load handling capability at elevated temperatures had a difference of only 9%. This is an excellent result. **Location L7.**

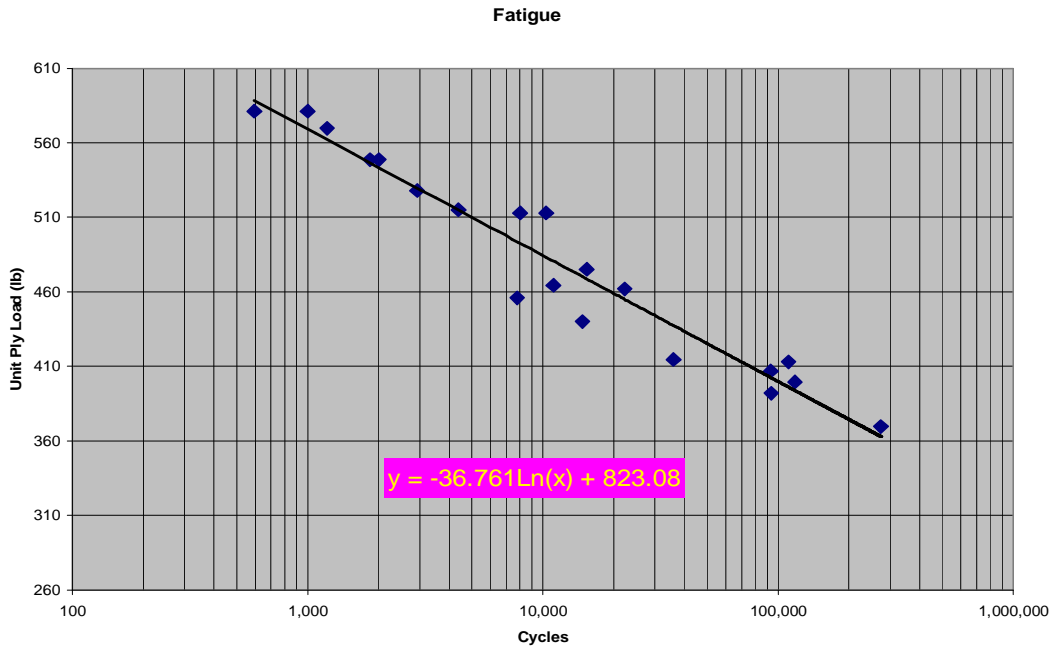
3.22 Cyclic Loading: Test number 907198A. The results of the testing to date are shown in the following graph. The baseline load per ply of this material is 801 pounds per ply. **Location L7.**

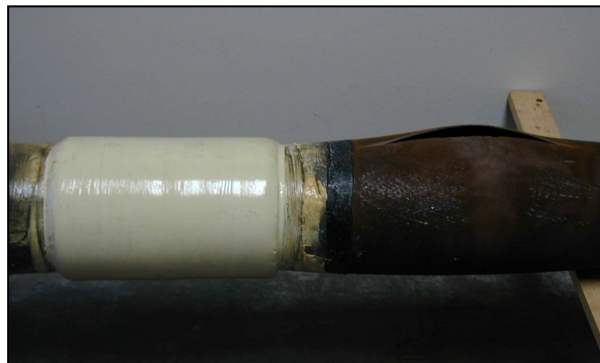
Figure 4.2  
12.75" OD pipe with ruptured section adjacent to wrap.

3. 12.75" OD Pipe (Serial #958497) -  
This section of pipe had a machined defect measuring 6" long x 1.47" wide x .125" deep (50% wall loss). The pipe section was 60" long and closed at both ends with welded end caps. The wrap installation was fairly conservative, as the goal was to burst the pipe outside the wrap section. Using our current Aquawrap<sup>®</sup> Composite Wrap Reinforcement Calculator, the 62 layers that were applied equates to inputs of 400 pounds per ply for the material, using a 0.67 design factor for the composite, and a safety factor of 1.25. Location L2.

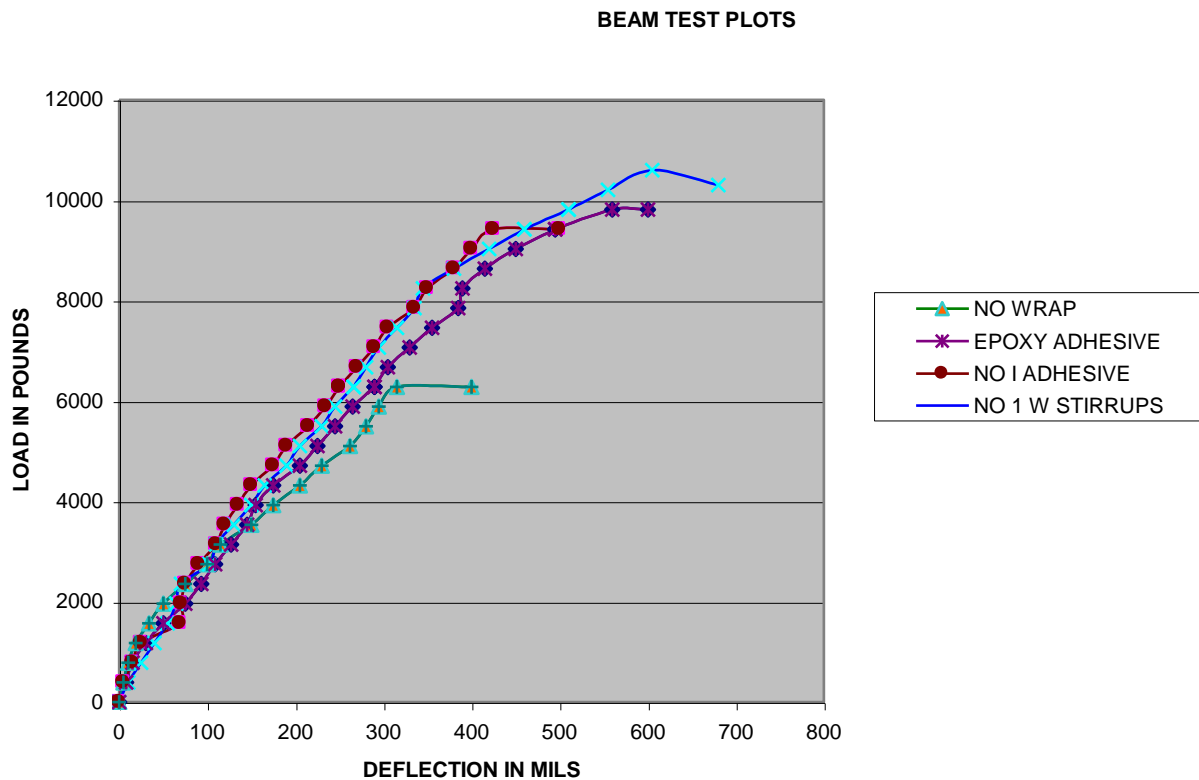
### Graph of Beam Test Results

The beams and their composite wraps were carefully examined after the tests and there was no evidence of voids or debonding from the concrete.

The underlying purpose of the above beam testing was to verify the high level of performance of the Aquawrap FRP System. Failure of the above Aquawrap strengthened beams, whether with urethane adhesive or epoxy adhesive, consistently occurred as compression failures of the concrete. There was no failure in the Aquawrap composite FRP system.
